# Pre-injector Upgrade Updates (15 Feb 2012 – 29 Feb 2012)

C.Y. Tan  
29 Feb 2012

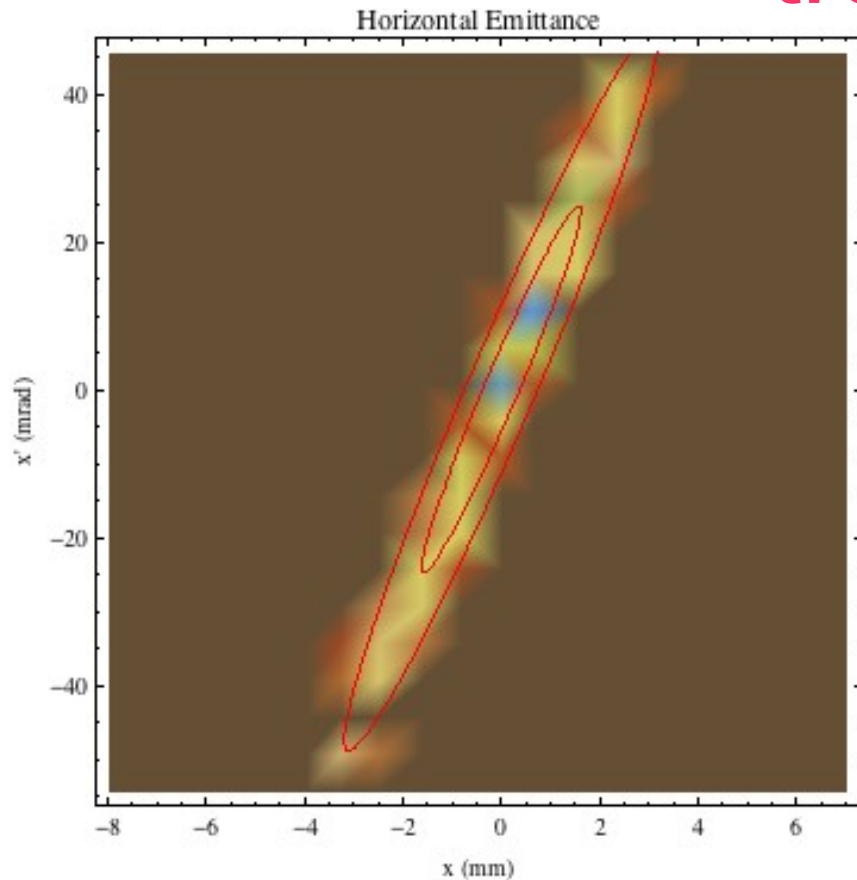
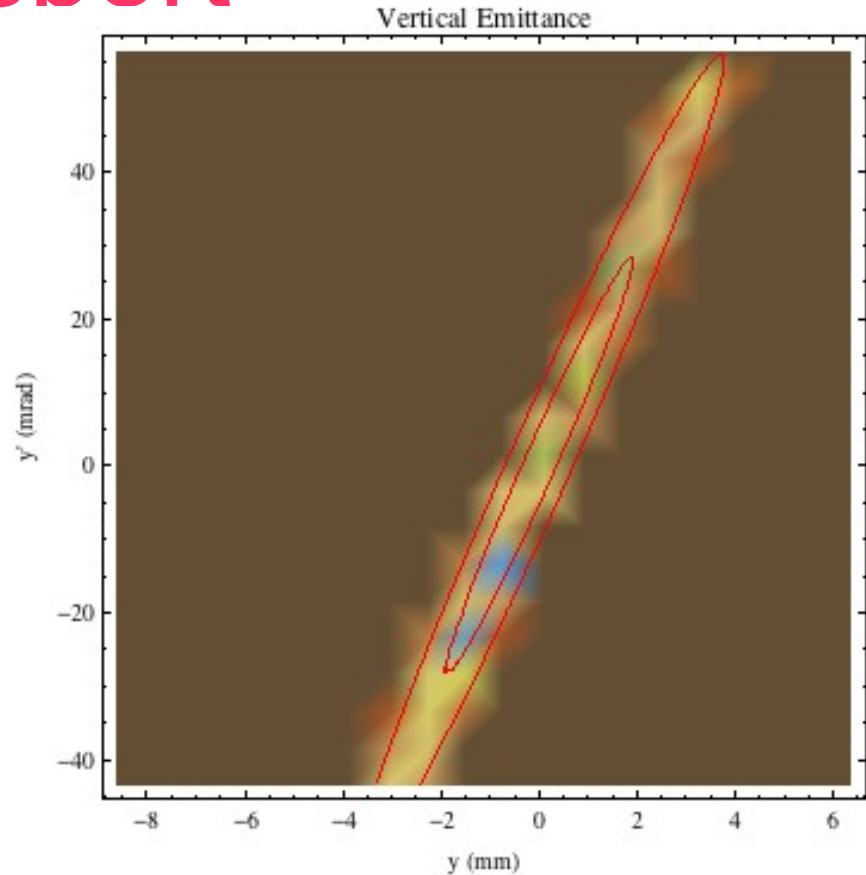
Note that beam is clearly truncated in both planes!  
Therefore, emittance calculations are too small,  
(0.8  $\pi$  mm mrad, 1 sigma normalized)  
Beam is at 35 keV, 60 mA.

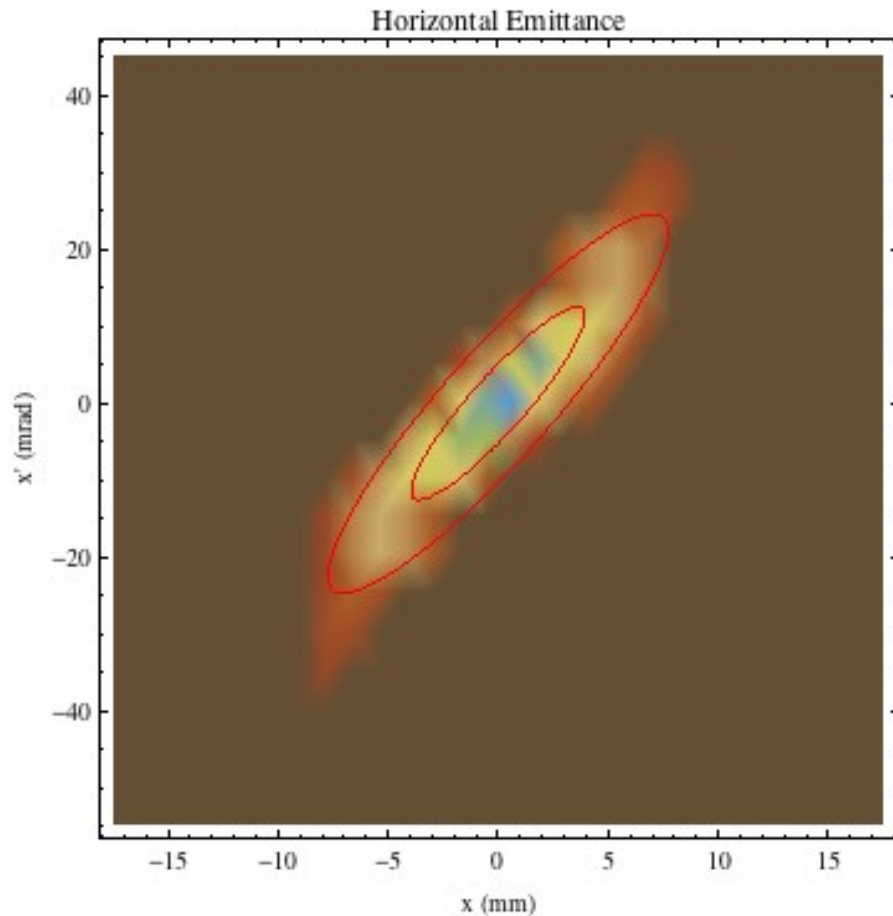
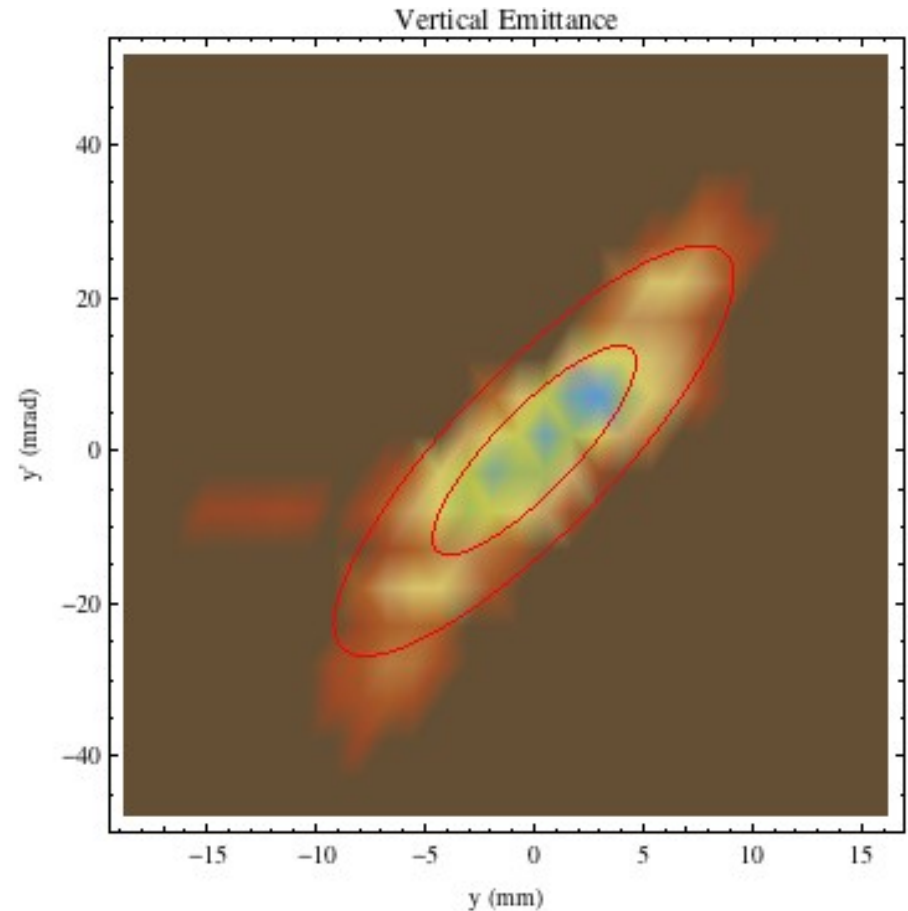
Emittances are assymetric!

Horz is 0.15 pi mm mrad 1 sigma normalized.

Vert is 0.25 pi mm mrad 1 sigma normalized.

Vert is 1.7x LARGER than horz!

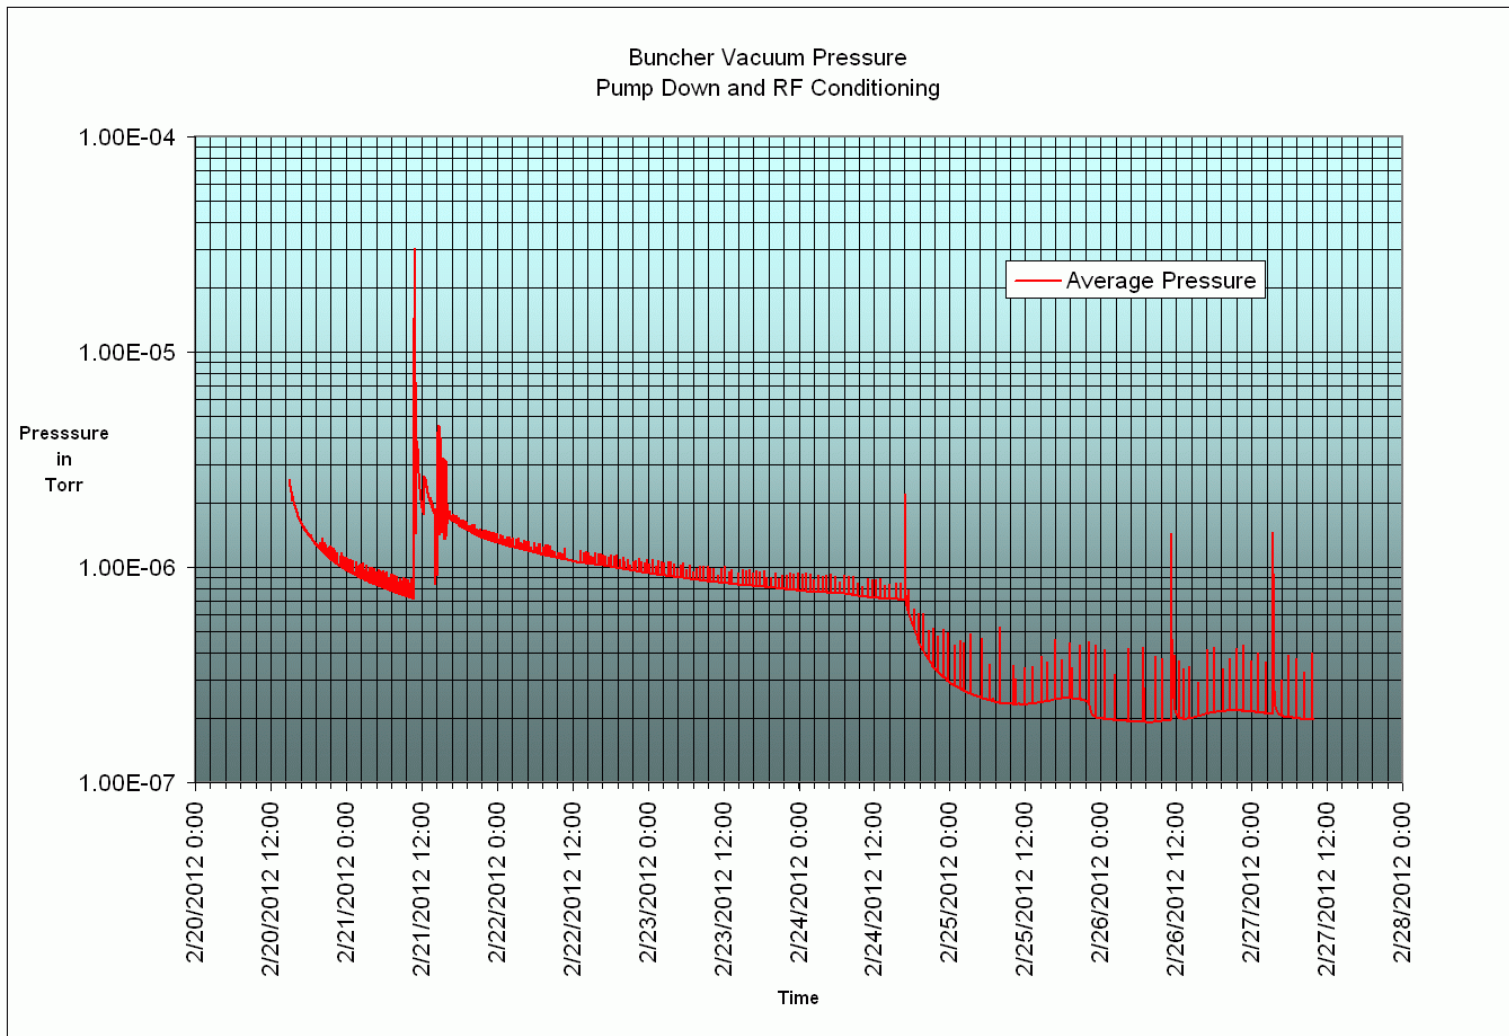
70W CW  
conditioning.

Spikes from  
ion pump ps?

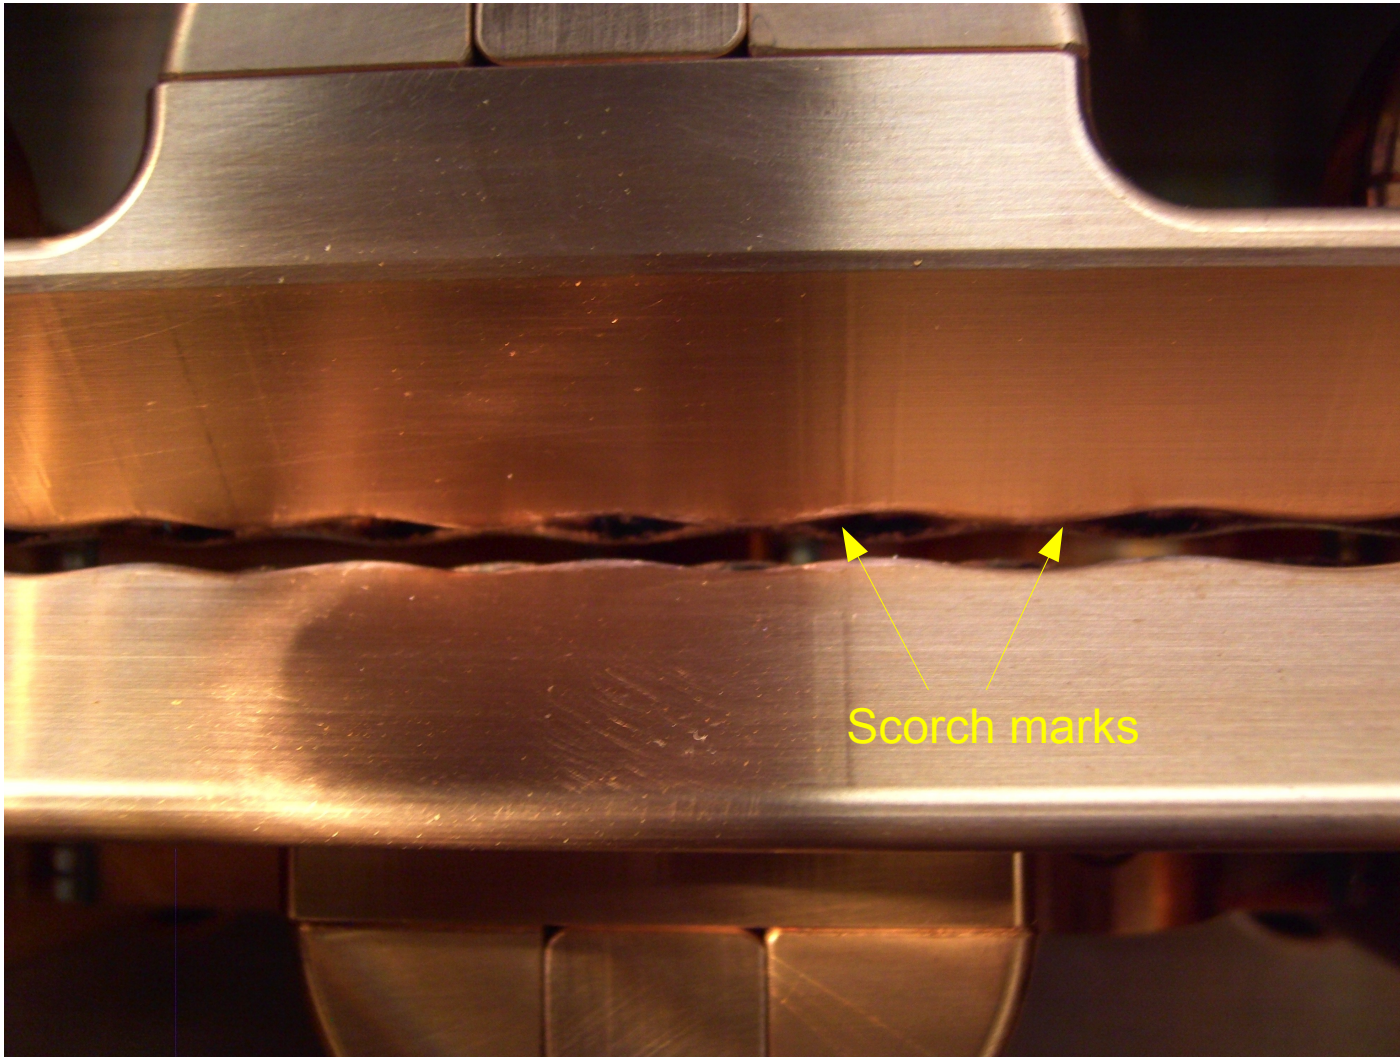
# Scorch Marks on nearly every vane tip

Notice that the top surfaces are clean.

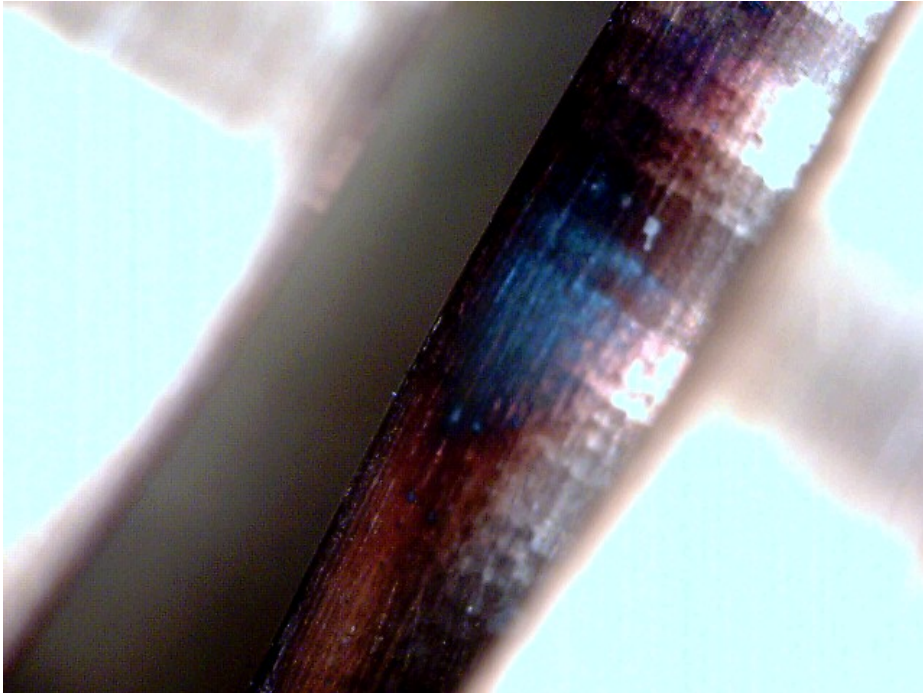
Zooming in on the scorch marks visible on from the top.

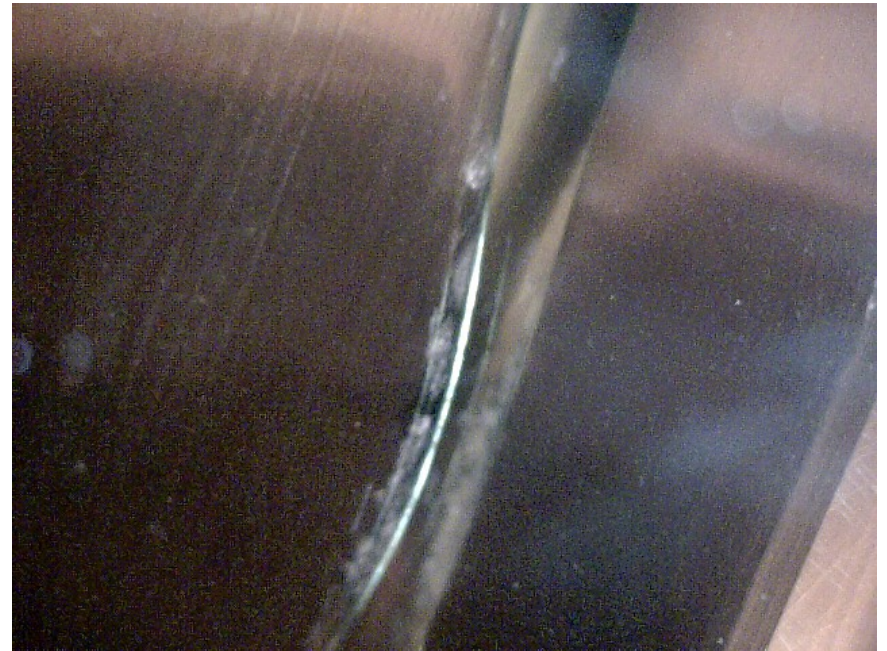
Zooming in on the bottom side of the same vane:

There are scorch marks here but they are silver and not black.

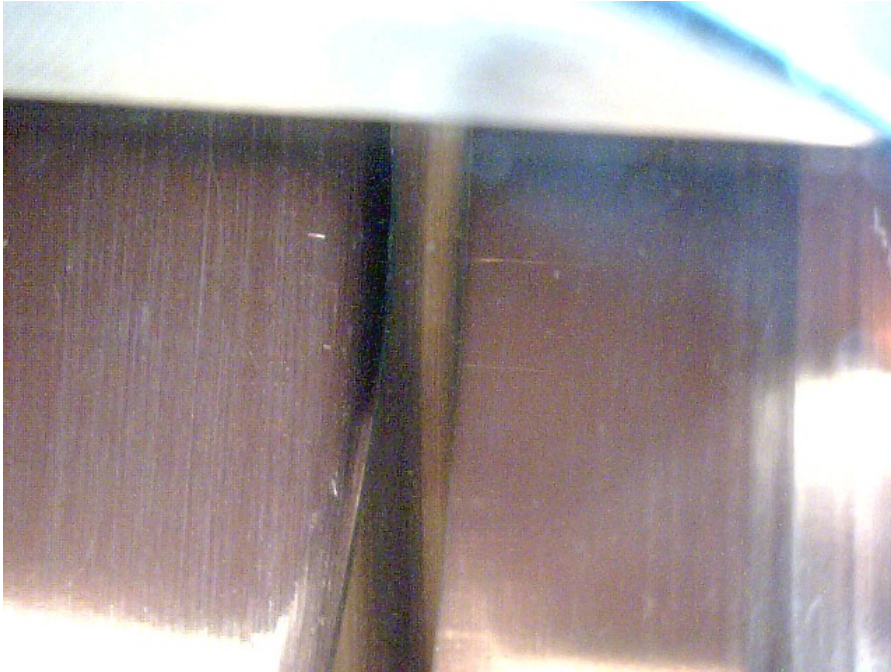
Zooming in to rods visible on the top but do **not** have scorch marks

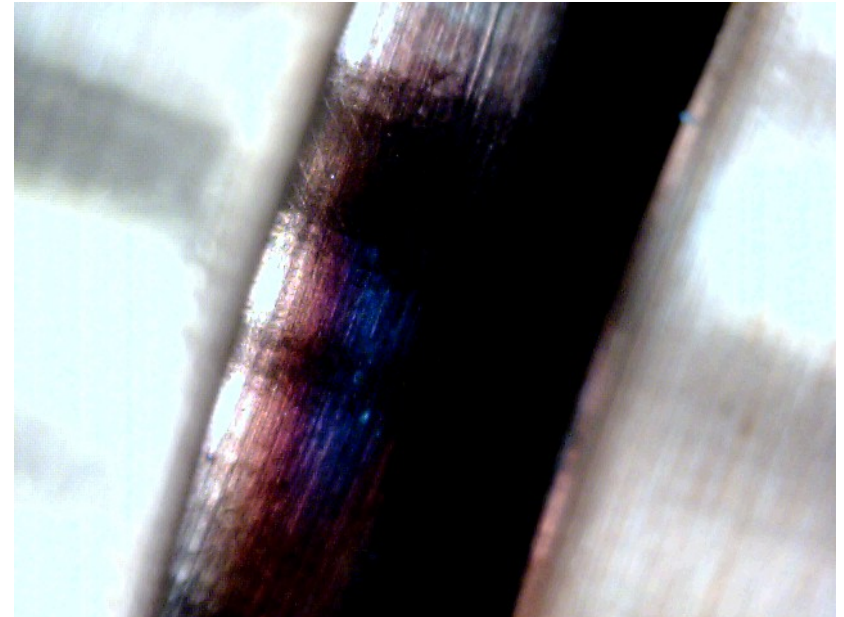
However, on the bottom side, the scorch marks are visible.

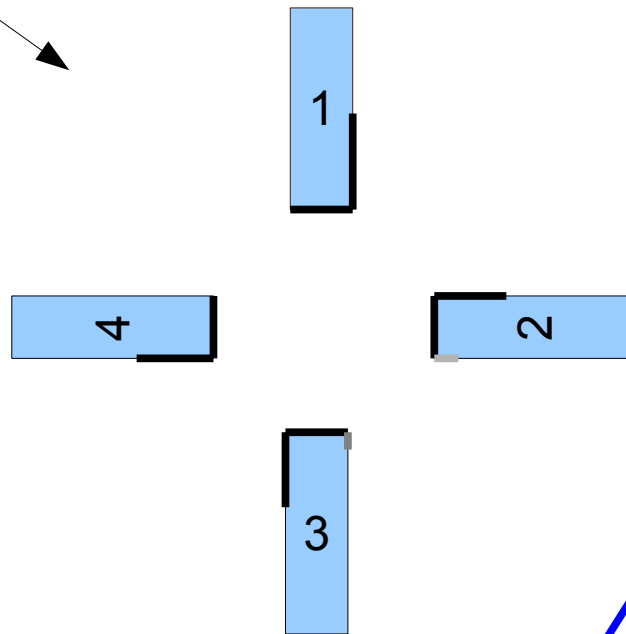
— Scorch marks  
— Light scorch marks

Visual inspection of the rods seem to show that rods 2 & 3 exhibit much worse scorching than rods 1 & 4.

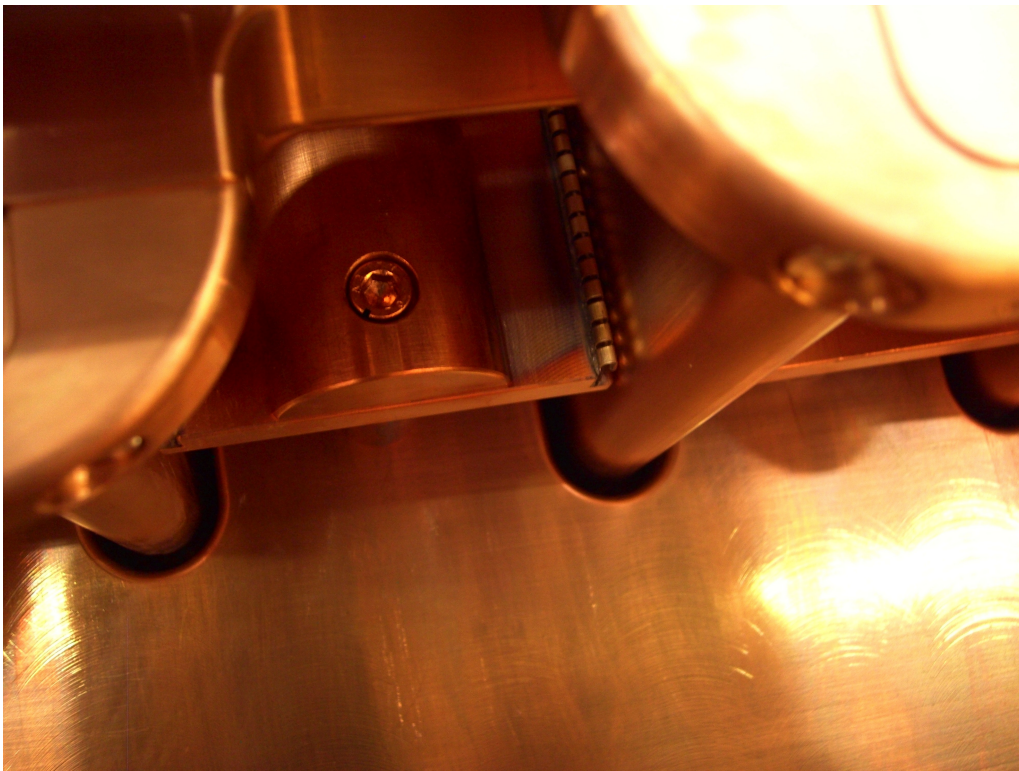
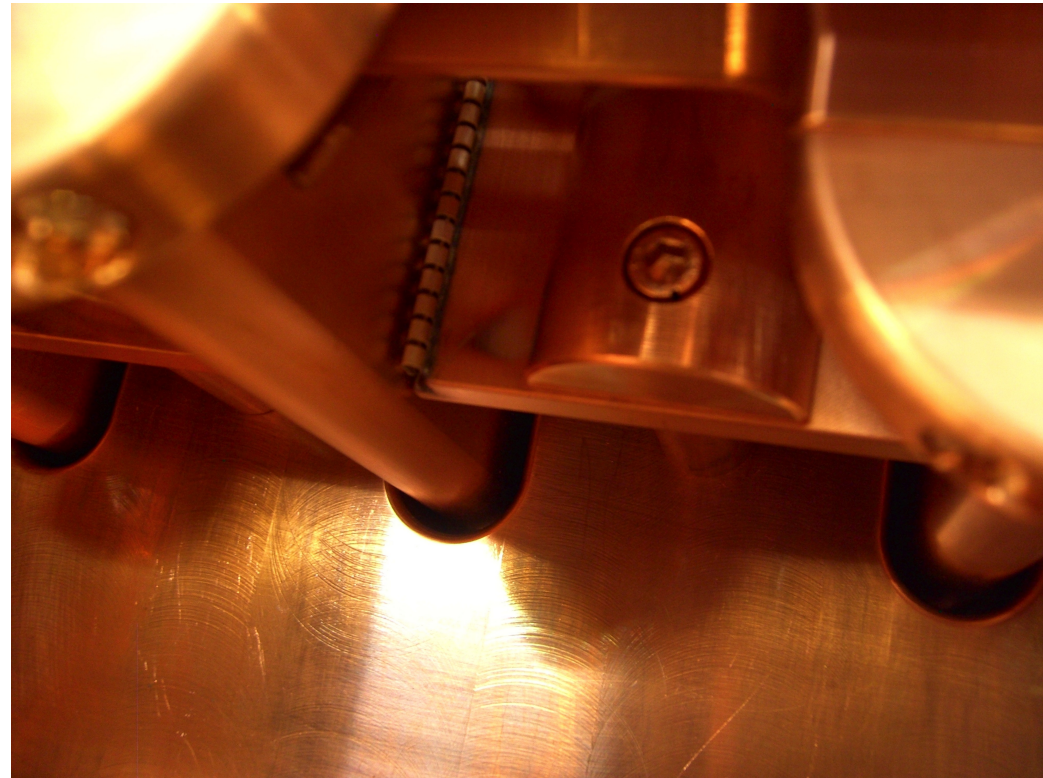
# Discolouration of the Tuning Plates

Silver discolouration of the tuning plates and some dark marks on edges of the silver region.

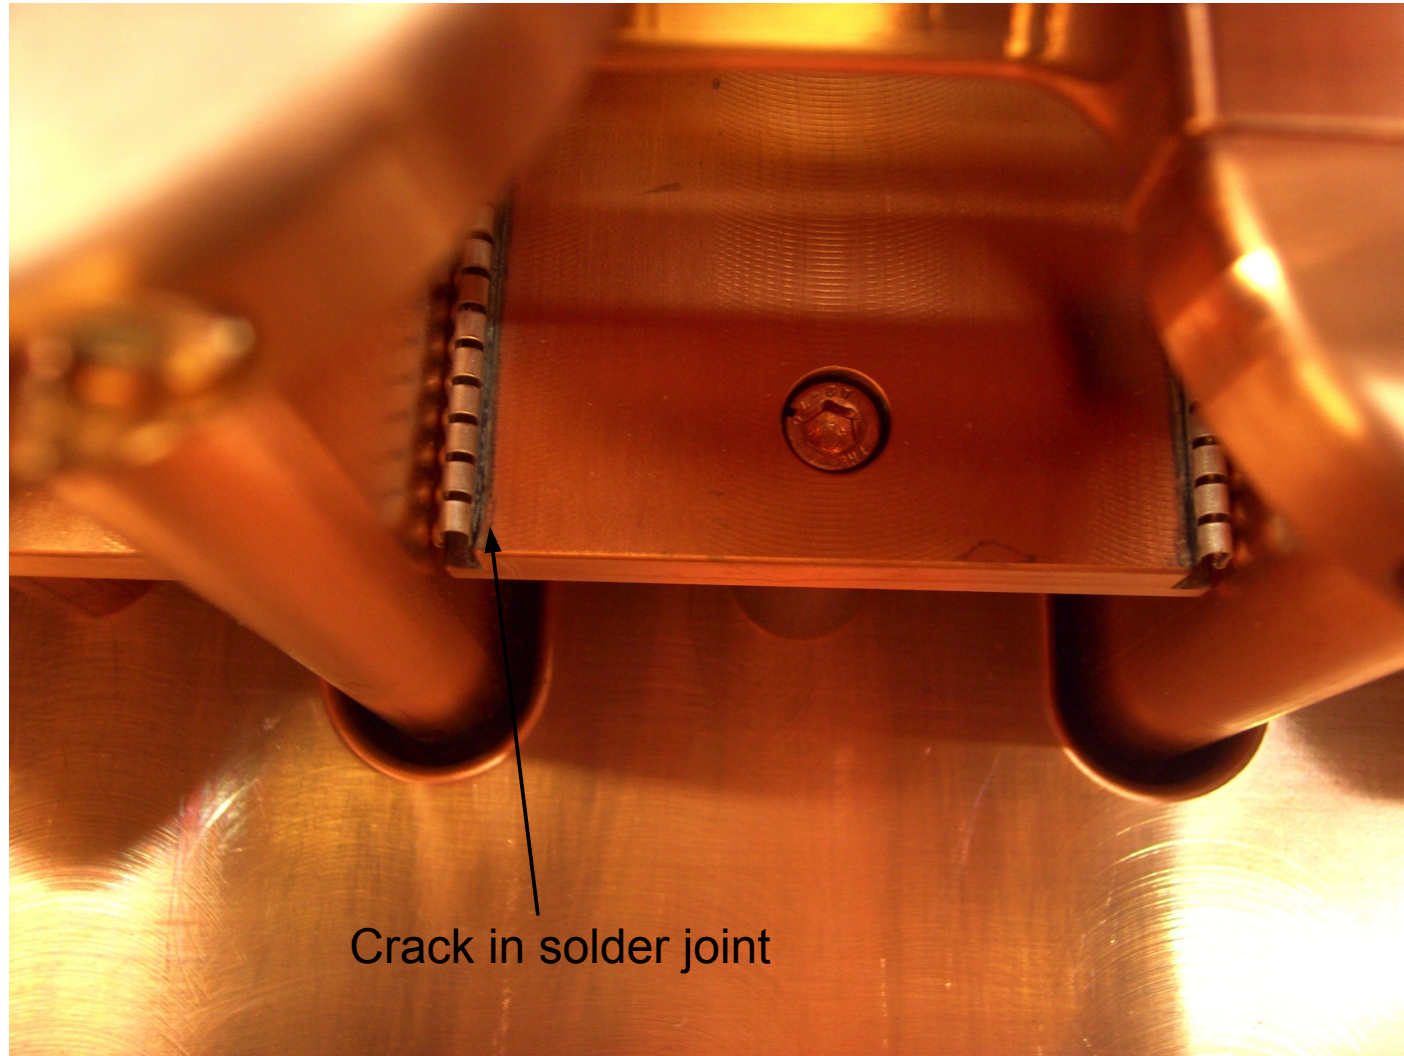
# Crack in solder joint

Manufacturing defect or  
localised RF heating  
caused this.

Crack in solder joint
